IBM System Storage SAN Volume Controller

Service Guide - Errata

Version 4.1.0

August 3, 2006

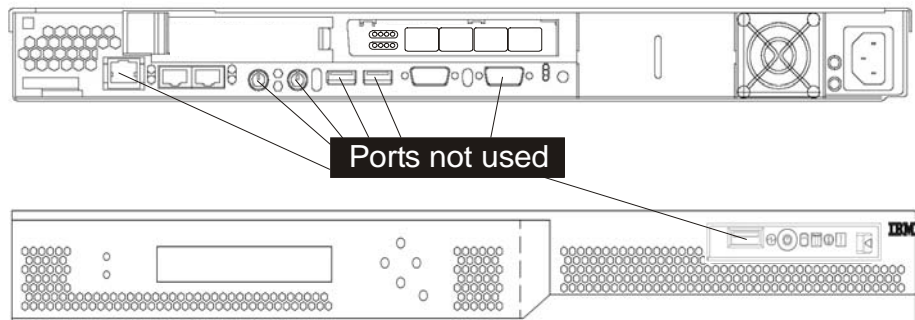
Figure 20. Ports not used

The SAN Volume Controller 2145-8F4 is equipped with several ports which are not used by the SAN Volume Controller, and have not been tested. Use of these ports, in conjunction with the SAN Volume Controller 2145-8F4 or any other application that might be run on this hardware, is not supported. See Figure 20 for those ports that are not used. In some countries these ports will be covered with self-adhesive non-removable labels.
