Procedures for Replacing 2145-4F2 Nodes with 2145-CF8 Nodes

Version 1.0
December, 2009

This document provides procedures for either non-disruptively or disruptively, replacing 2145-4F2 nodes in an existing SAN Volume Controller with 2145-CF8 nodes while upgrading to SAN Volume Controller version 5.1.0. It provides important information to avoid problems while following the procedures.

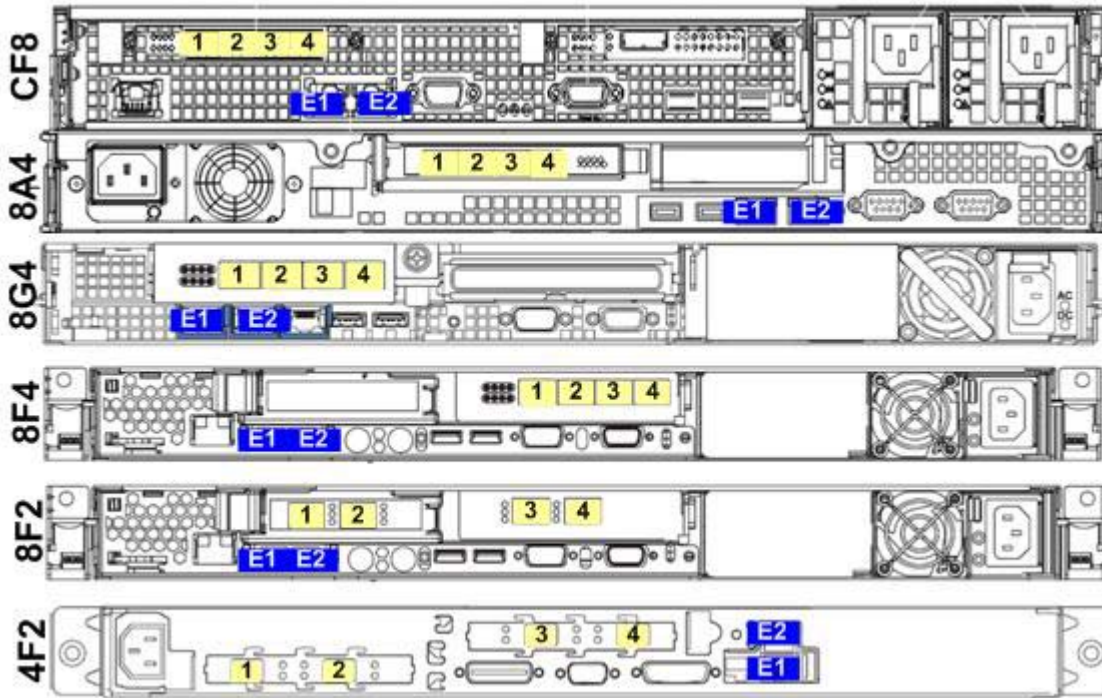
- Record and mark the fibre-channel cables with the SAN Volume Controller node port number (1-4) and remove the cables from the back of the node. You must reconnect the cables to the new 2145-CF8 node exactly as they were connected to the removed node. At the back of the node, the fibre-channel ports are numbered 1-4 from left to right. However, note that there are no numerical markings on the ports themselves. The cables must be reconnected to the same port number that they were removed from, or the fibre-channel port IDs will change, which can impact host access to VDisks or cause problems adding the new node to the cluster. Do not move any fibre-channel cables between ports in the switch or director either.
