IBM System Storage SAN Volume Controller Troubleshooting Guide

Version 6.2.0

GC27-2284-01

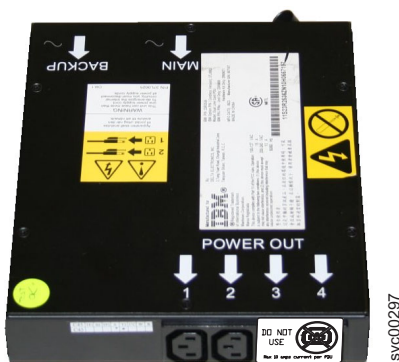
Figure 47. Photo of the redundant ac-power switch

Figure 47 shows a redundant ac-power switch.

The redundant ac-power switch is an optional feature that makes the SAN Volume Controller nodes resilient to the failure of a single power circuit. The redundant ac-power switch is not a replacement for an uninterruptible power supply. You must still use a uninterruptible power supply for each node.

You must connect the redundant ac-power switch to two independent power circuits. One power circuit connects to the main power input port and the other power circuit connects to the backup power-input port. If the main power to the SAN Volume Controller node fails for any reason, the redundant ac-power switch automatically uses the backup power source. When power is restored, the redundant ac-power switch automatically changes back to using the main power source.

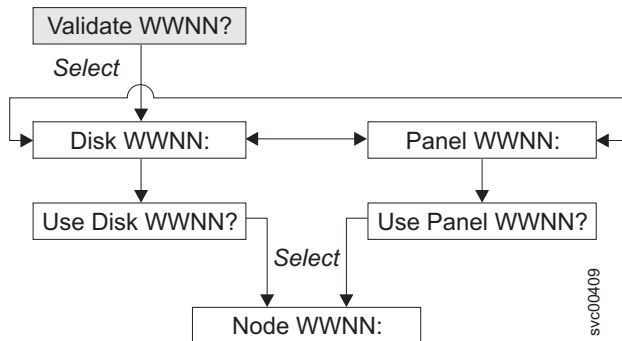
Figure 59. Validate WWNN? navigation

After it is in this mode, the front panel display will not revert to its normal displays, such as node or cluster (system) options or operational status, until the WWNN is validated. Navigate the Validate WWNN option (shown in Figure 59) to choose which WWNN that you want to use.
