IBM System Storage SAN Volume Controller
Version 6.3.0

Troubleshooting Guide

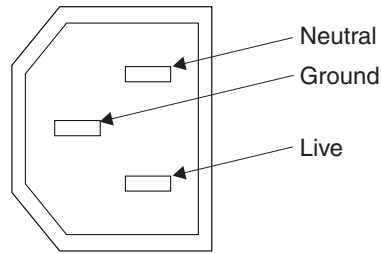
Figure 19 on page 21 shows the type of connector that is located on each power-supply assembly. Use these connectors to connect the SAN Volume Controller 2145-CG8 to the two power cables from the uninterruptible power supply.

Figure 19. Power connector
