IBM System Storage SAN Volume Controller  
Version 6.4.0

*Troubleshooting Guide*

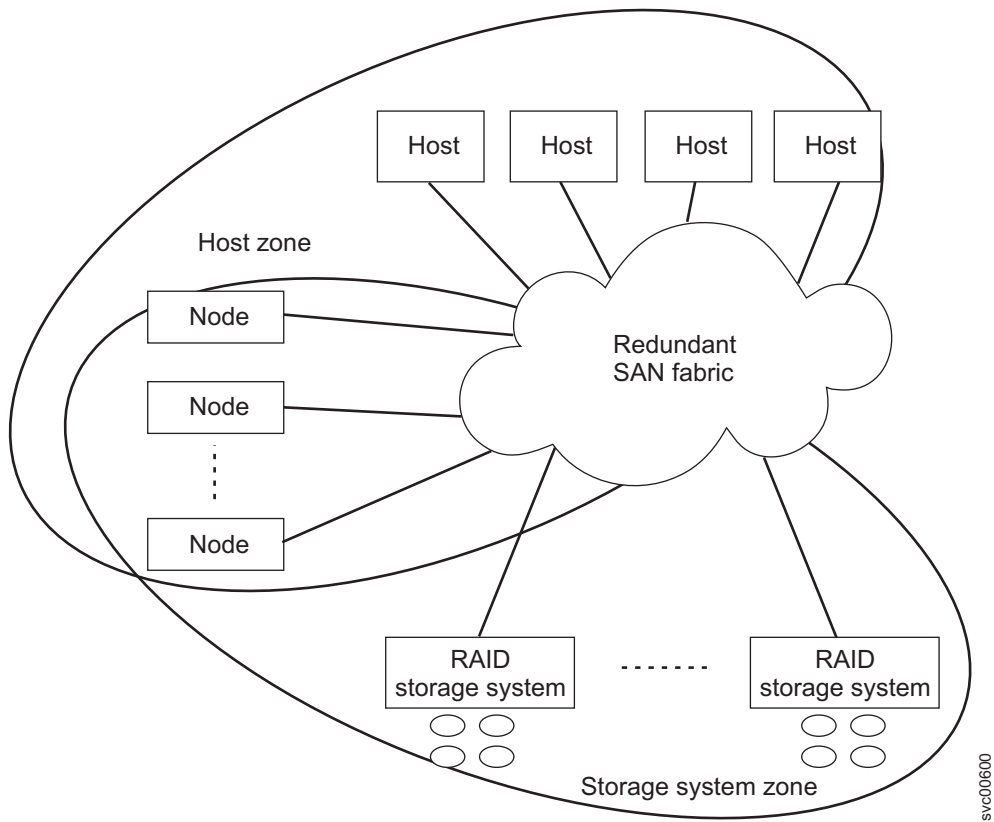
Figure 1 on page 2 shows hosts, SAN Volume Controller nodes, and RAID storage systems connected to a SAN fabric. The redundant SAN fabric comprises a fault-tolerant arrangement of two or more counterpart SANs that provide alternate paths for each SAN-attached device.

Figure 1. SAN Volume Controller system in a fabric

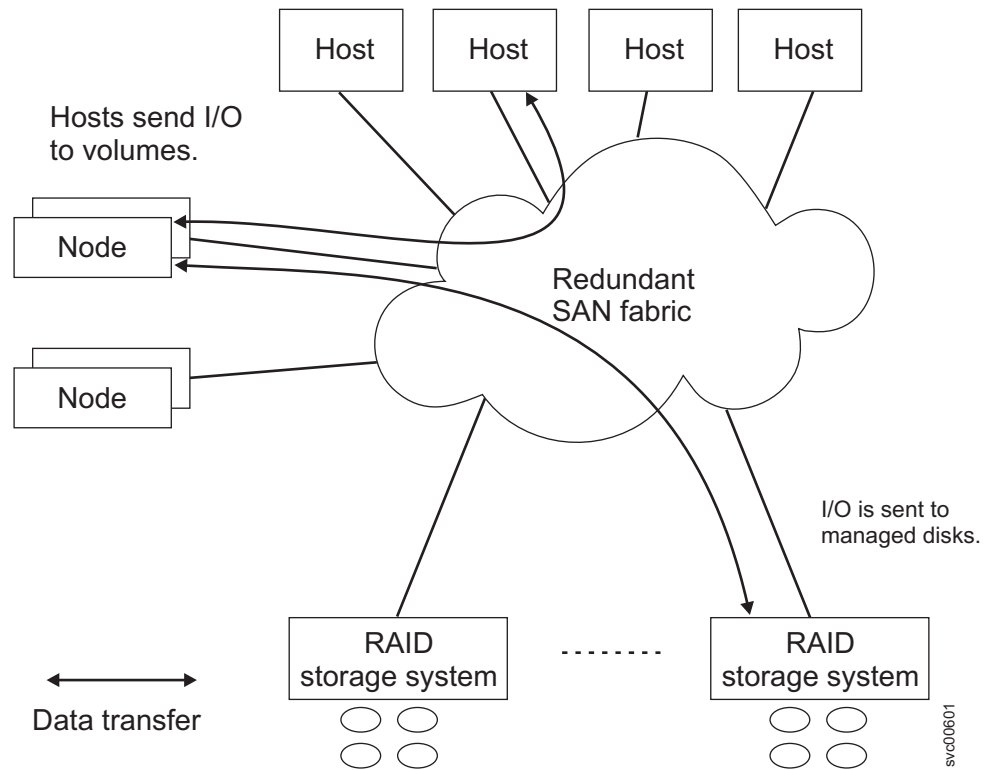
A system of SAN Volume Controller nodes presents volumes to the hosts. Most of the advanced functions that SAN Volume Controller provides are defined on volumes. These volumes are created from managed disks (MDisks) that are presented by the RAID storage systems. All data transfer occurs through the SAN Volume Controller nodes, which is described as symmetric virtualization.

Figure 2 shows the data flow across the fabric.

Figure 2. Data flow in a SAN Volume Controller system

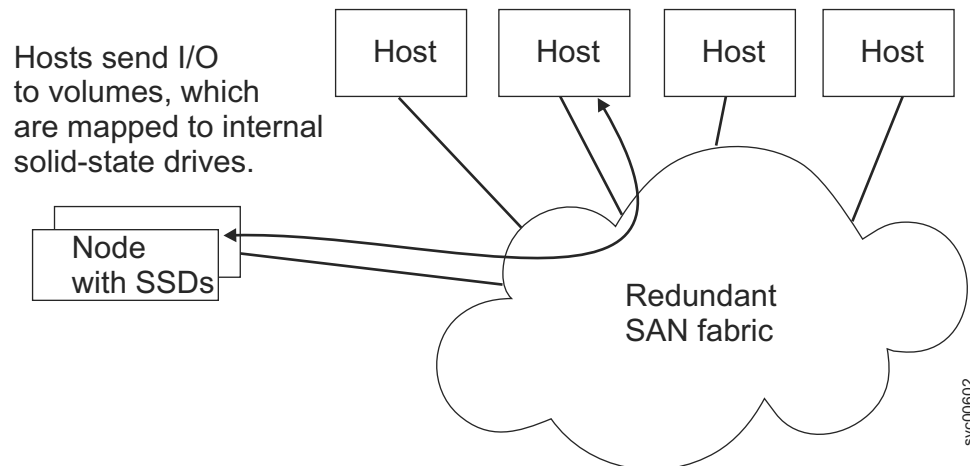
Figure 3 shows this configuration. Internal SSD MDisks can also be placed in a storage pool with MDisks from regular RAID storage systems, and IBM System Storage Easy Tier performs automatic data placement within that storage pool by moving high-activity data onto better performing storage.

Figure 3. SAN Volume Controller nodes with internal SSDs

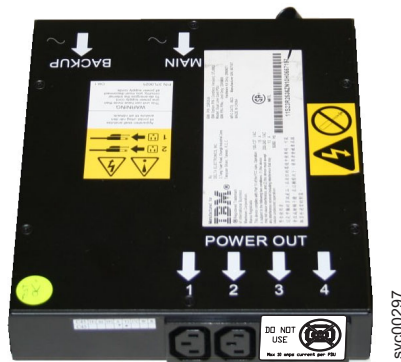
Figure 47 shows a redundant ac-power switch.

Figure 47. Photo of the redundant ac-power switch

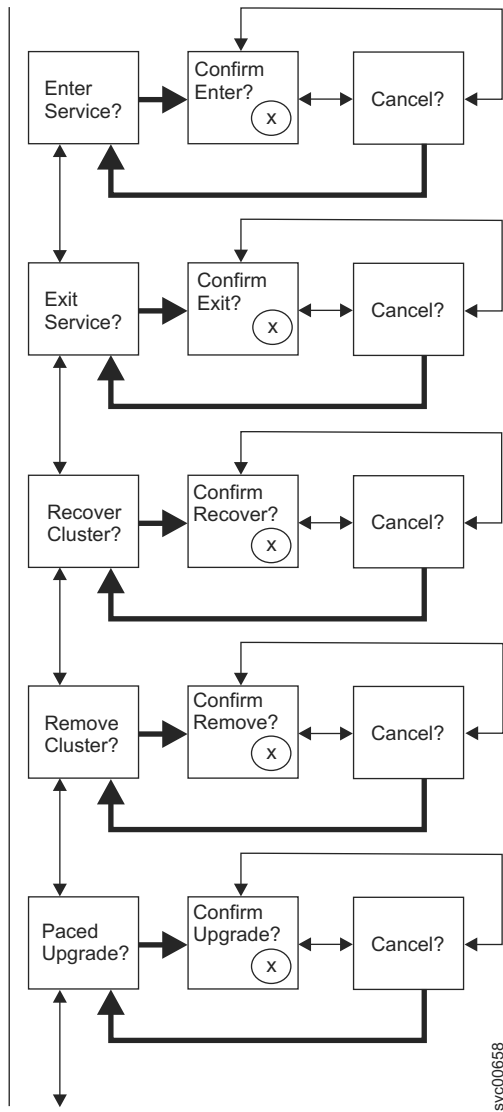
Figure 63. Middle options of the actions menu on the front panel

Figure 62 on page 110, Figure 63 on page 111, and Figure 64 on page 112 show the sequence of the actions options. In the figures, bold lines indicate that the select button was pressed. The lighter lines indicate the navigational path (up or down and left or right). The circled X indicates that if the select button is pressed, an action occurs using the data entered.

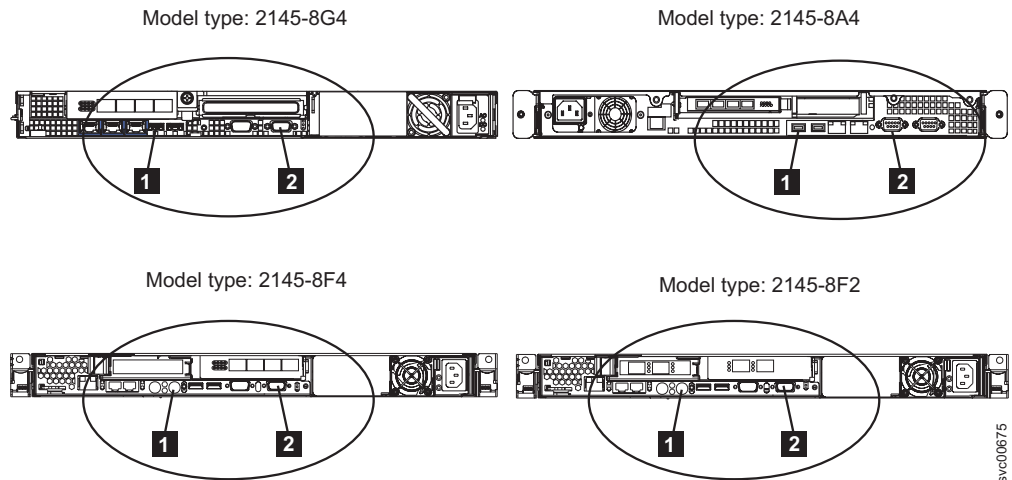
Figure 105. Keyboard and monitor ports on the SAN Volume Controller models 2145-8G4, 2145-8A4, 2145-8F4 and 2145-8F2

- a. Turn off the node while ensuring that its data is mirrored and synchronized. See “MAP 5350: Powering off a SAN Volume Controller node” on page 258.
- b. Connect the keyboard **1** and the display **2**. Figure 105 on page 305 shows the location of the keyboard and monitor ports. Figure 106 on page 305 shows the location of the keyboard and monitor ports on the 2145-CF8. Figure 107 on page 305 shows the location of the keyboard and monitor ports on the 2145-CG8.
