Customer Installation Instructions

TS7510 Patch Update for 3954-CV5 Virtualization Engine

Fixes issue with tape getting overwritten by TSM after failover, reboot, or services restart.

TS7510 Software Version 1.1 (Build 1143)

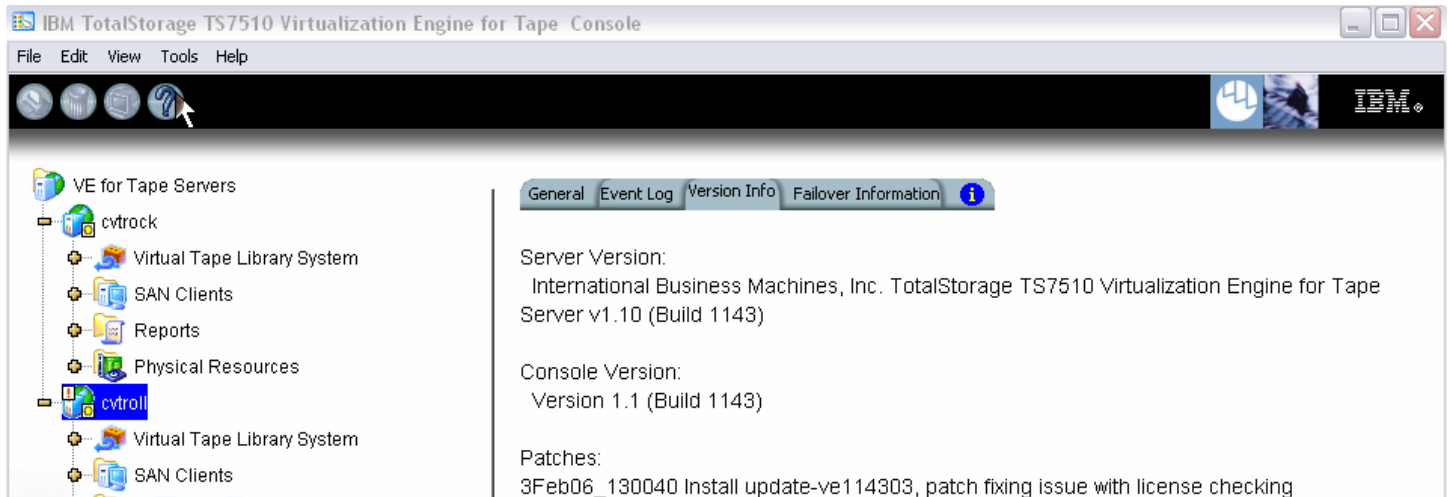
Figure-1

You can check the version of TS7510 software, and whether the patch is installed, using the VE Console *Version Info* tab (refer to Figure-1).

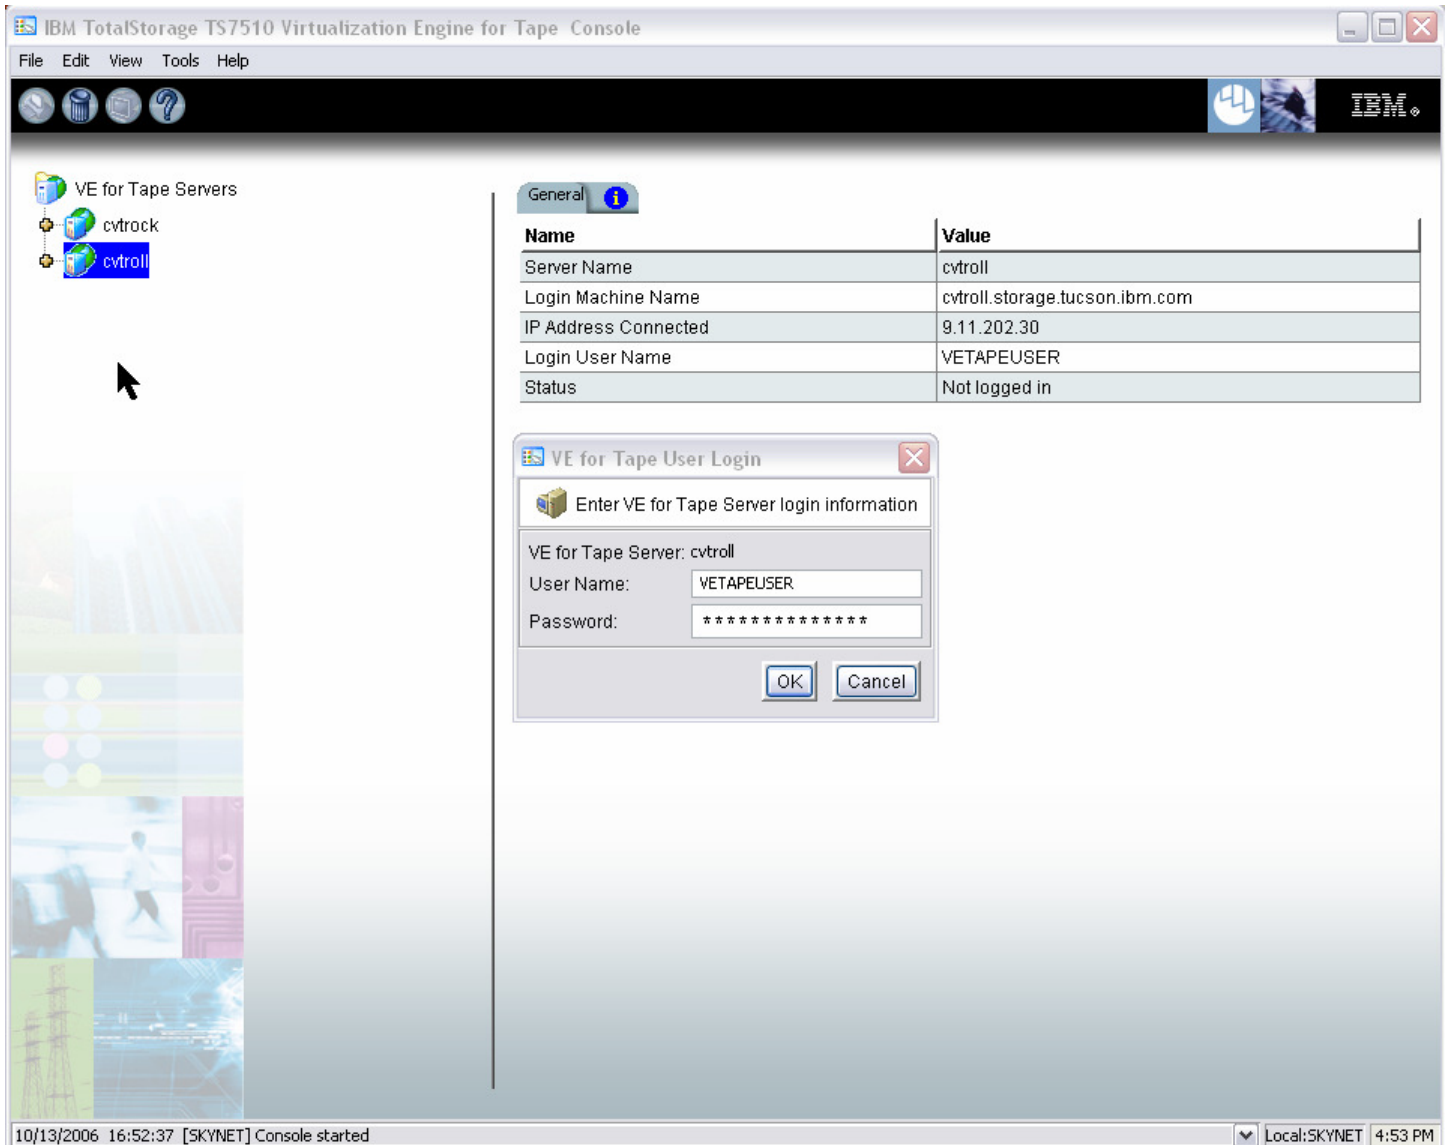
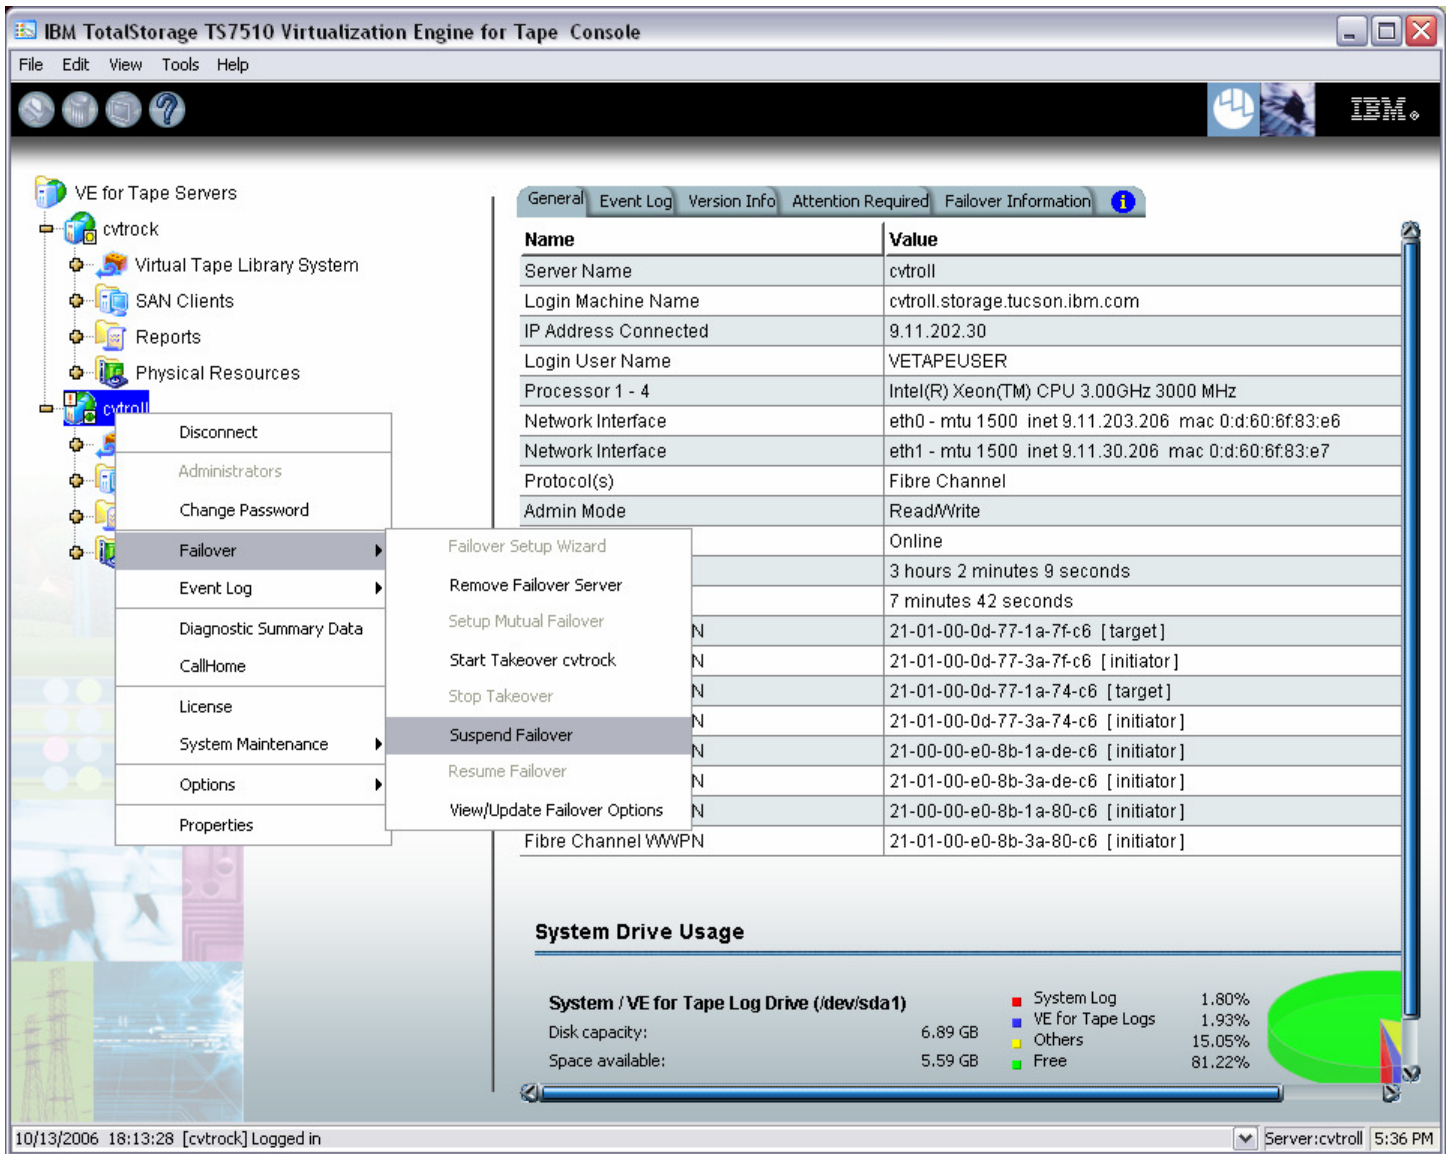
For HA configurations (FC-7420 Failover/Failback Enable), use the VE Console to Suspend Failover on both 3954-CV5 servers. Refer to Figure-2 and Figure-3, and use the following procedure to Suspend Failover **on each server (both the upper and lower server if in an HA environment)**.

1. Login to the VE for Tape server, or highlight the VE for Tape server if already connected.
The login userid is “VETAPEUSER” and the password is “VEUSERPASSWORD”
2. With your mouse Right-click on the VE Console, a context menu will appear, select *Failover*, then select *Suspend Failover*.

For HA configurations (FC-7420 Failover/Failback Enable), use the VE Console to Resume Failover on both 3954-CV5 servers. Refer to Figure-3 and the following procedure to Resume Failover **on each server (both the upper and lower server if in an HA environment)**.

1. Highlight the VE for Tape server
2. With your mouse Right-click on the VE Console, a context menu will appear, select *Failover*, then select *Resume Failover*.

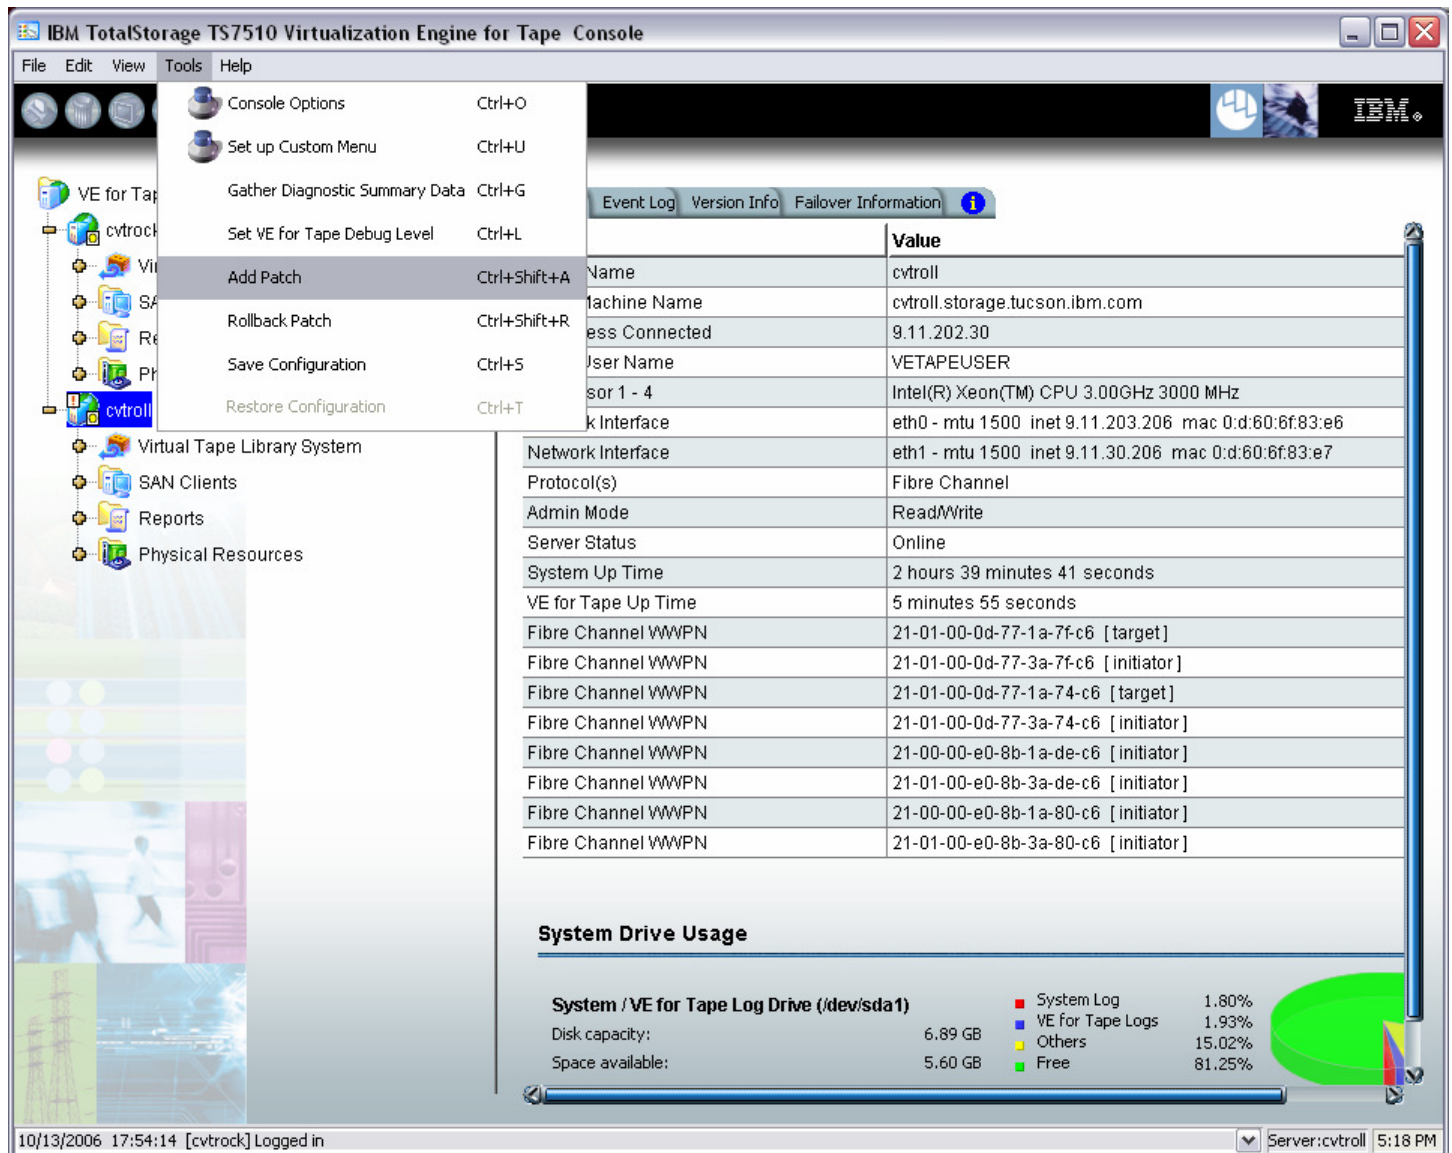
1. Highlight the VE for Tape server, select the *Tools* button on the Menu bar, and select *Add Patch* (Figure-4)

Use the VE Console *Add Patch* option to install the patch. Refer to Figure-4 through Figure-7 and **use the following procedure to install the patch on each 3954-CV5 VE for Tape server (both the upper and lower server if in an HA environment).**

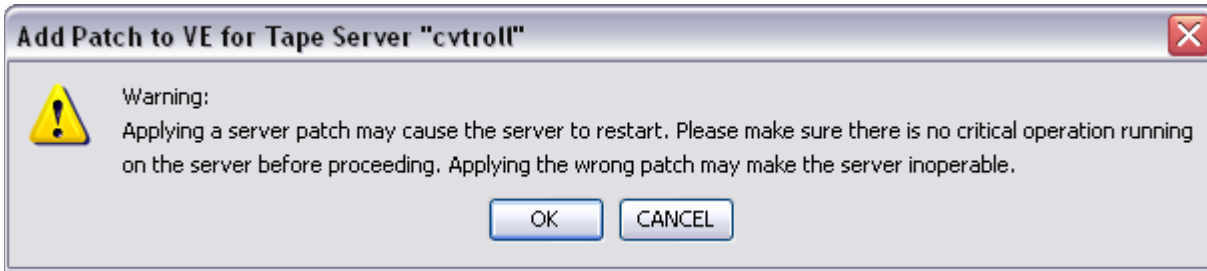
Figure-5

2. Select “OK” when presented with the following Warning Message (Figure-5)

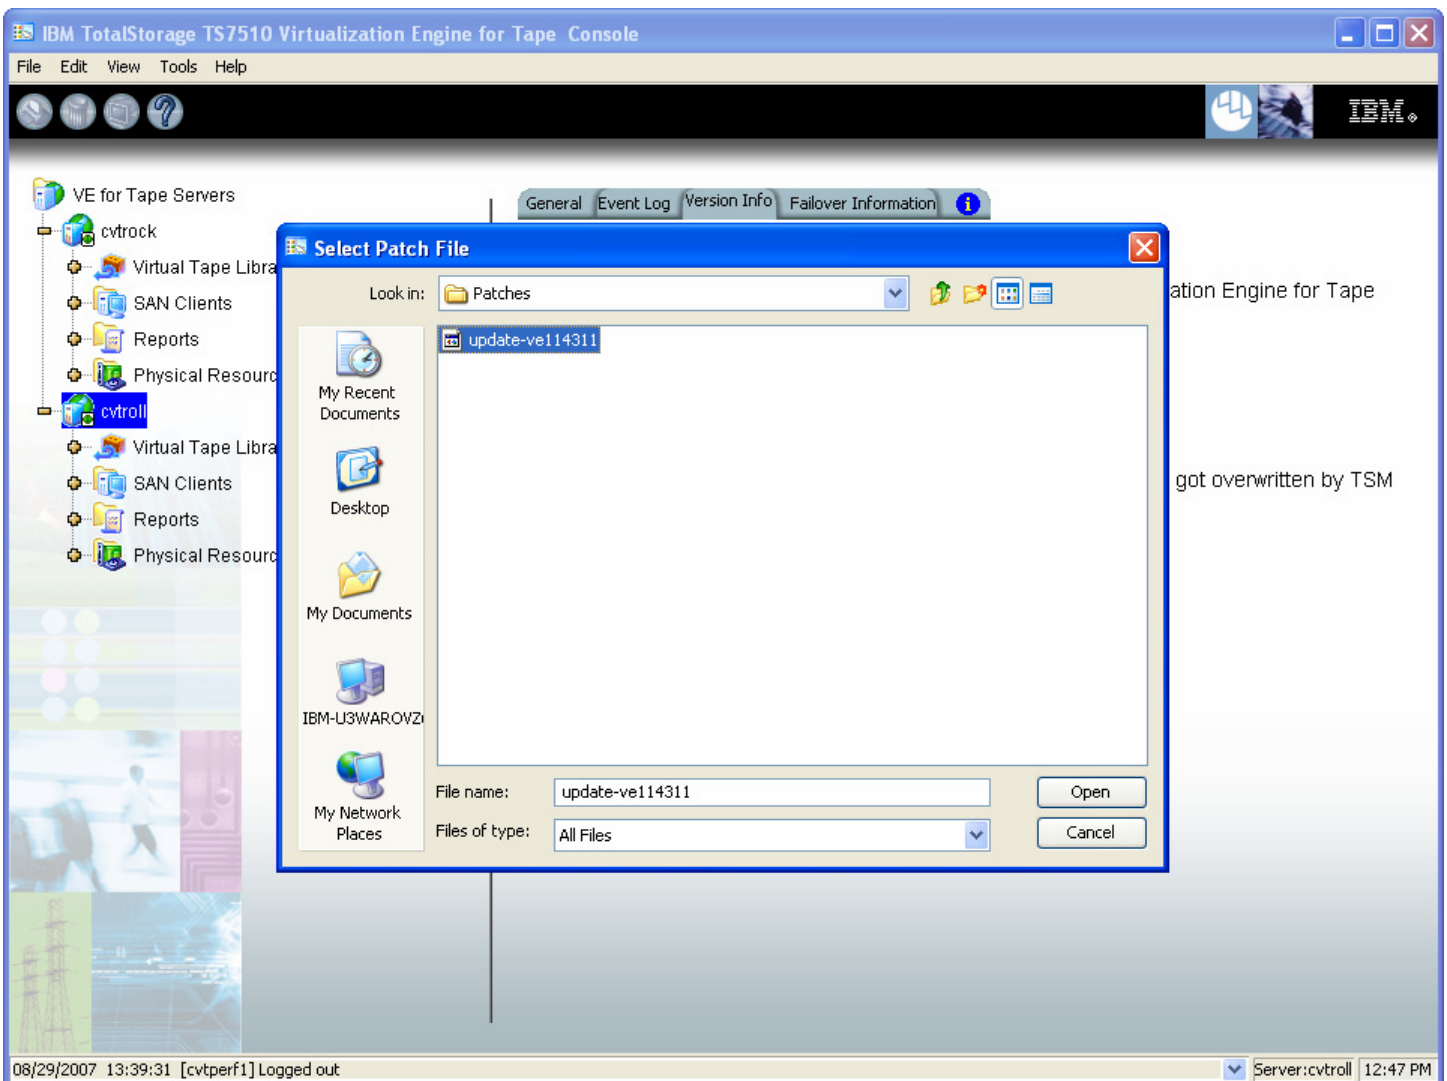
Figure-6

3. When presented with the Select Patch File window (Figure-6), index to the VE Console directory where the *update-ve114311* patch file resides and select the file.

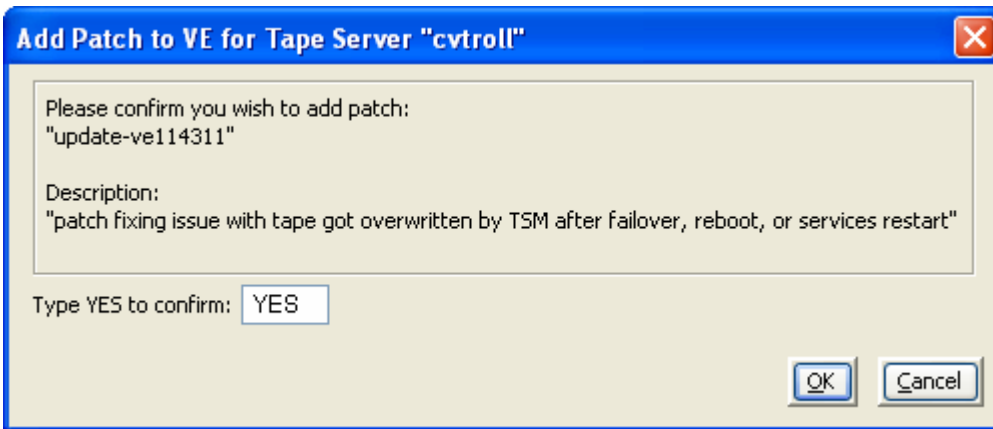
Figure-7

4. When presented with the confirmation window, type “YES” to confirm (Figure-7)

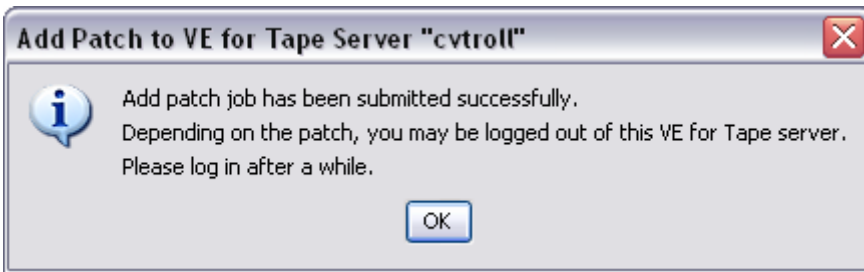
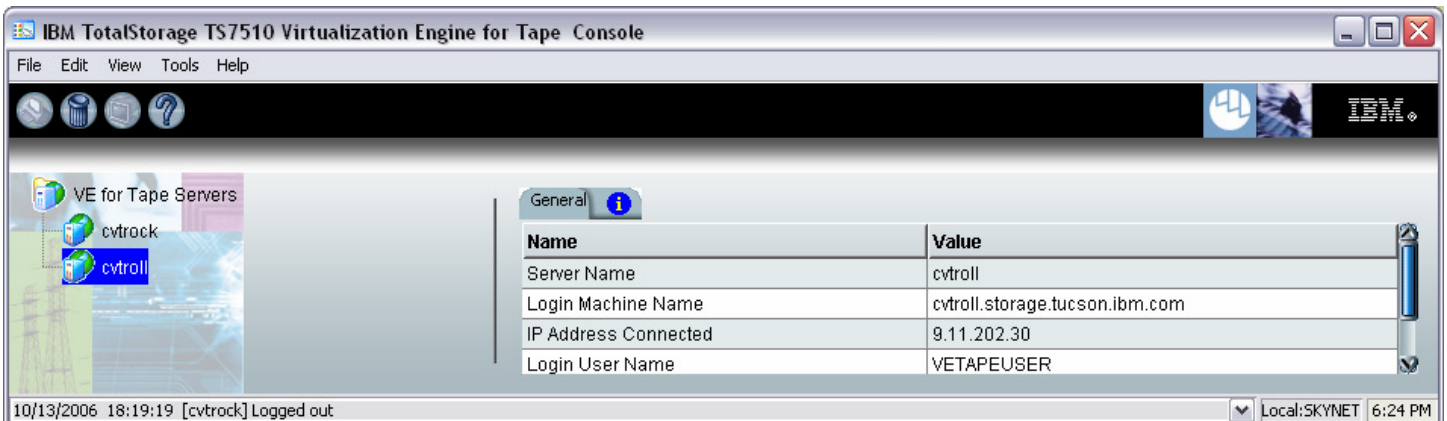
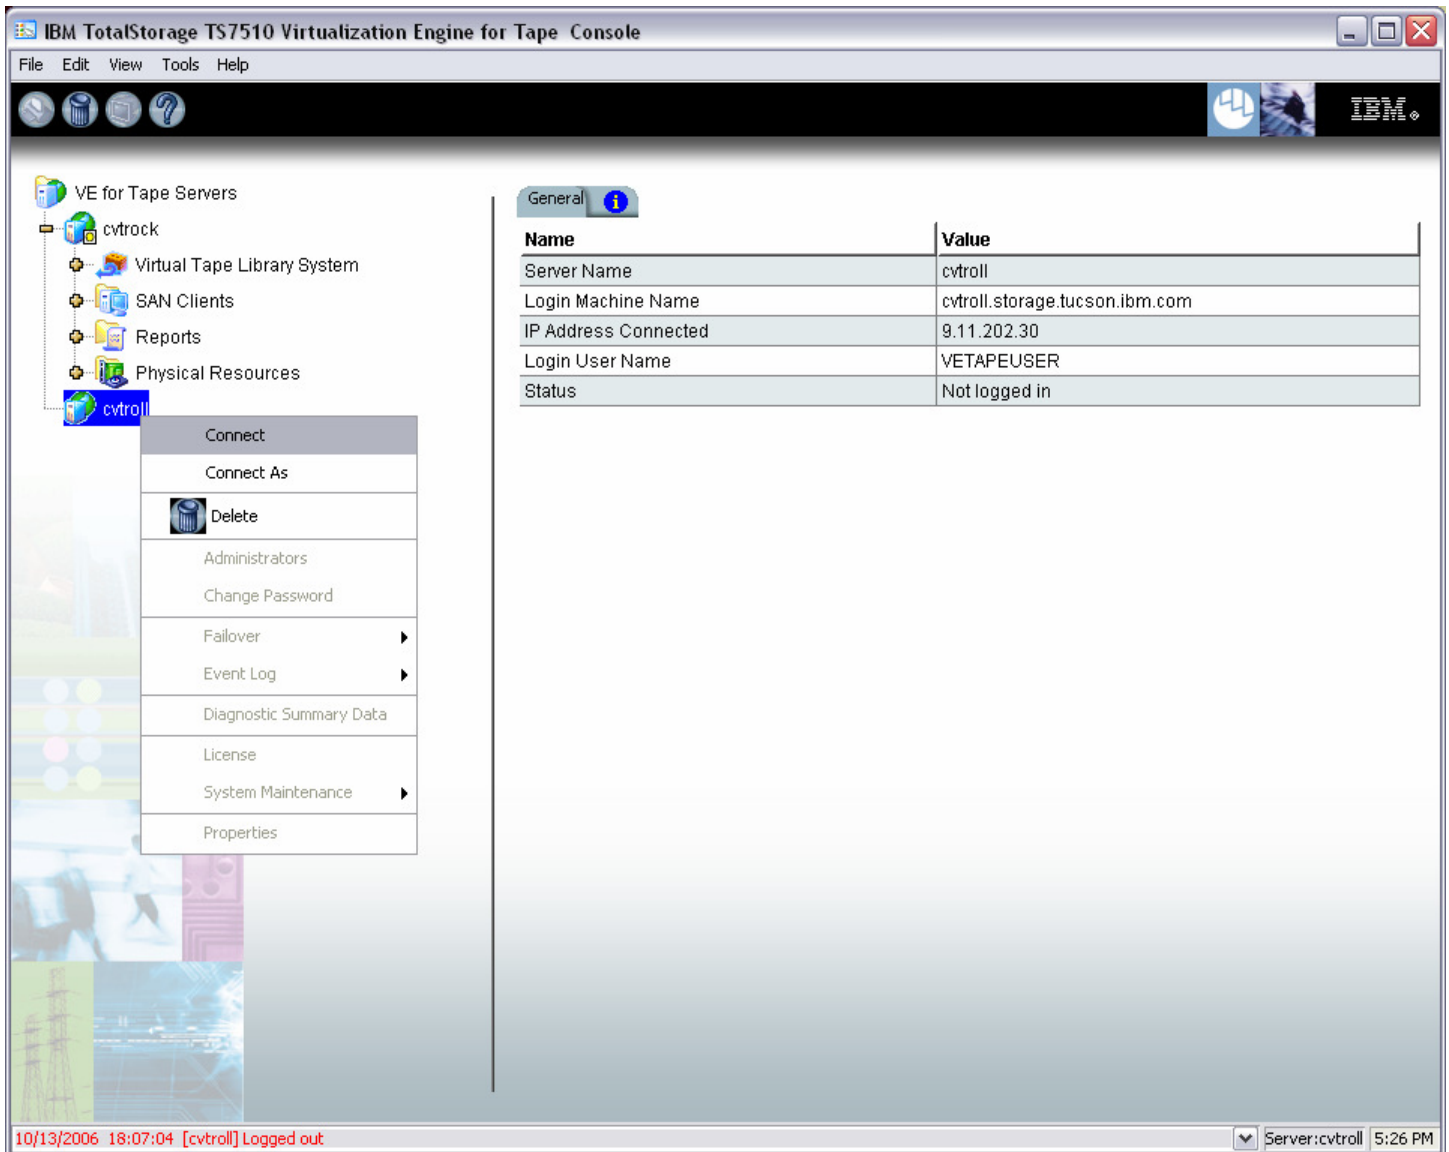
5. The server software will shutdown and restart (Figure-8). The VE Console will be disconnected from the VE for Tape server (Figure-9). Once the server software has completed the restart (approximately 30 seconds) you will be able connect to the VE for Tape server from the VE Console (Figure-10).

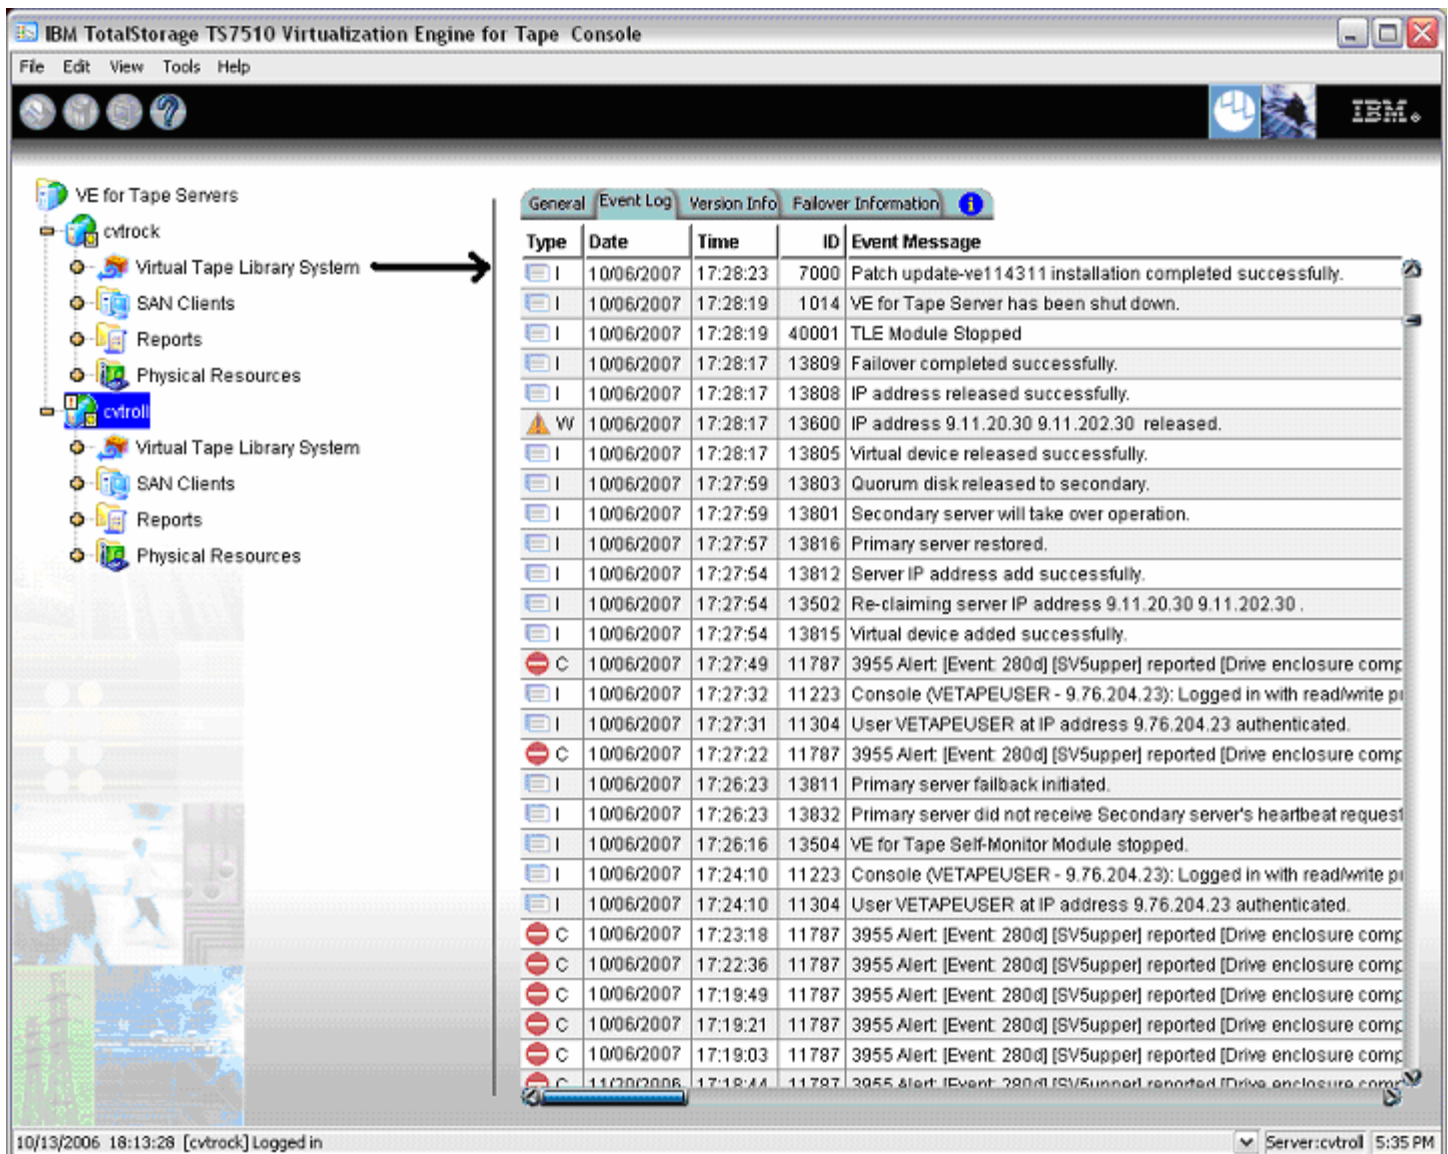
Figure-11

Check the TS7510 Event Log of each server, using the VE Console *Event Log* tab, to confirm the successful installation of the patch (refer to Figure-11). There should be an Event Log entry stating the “Patch update-ve114311 installation completed successfully”. **Note:** you may have to scroll through the log in order to find this entry depending on the configuration of your CVT.

Check the TS7510 Event Log of each server, using the VE Console *Event Log* tab, to confirm the successful installation of the patch (refer to Figure-11, top entry in log). There should be an Event Log entry stating the “Patch update-ve114311 installation completed successfully”. **Note:** you may have to scroll through the log in order to find this entry depending on the configuration of your CVT.
